Comments on Lower Colorado River Authority Fayette Power Project Draft Report

Assessment of Dam Safety of Coal Combustion Surface Impoundments

Sam Seymour - Fayette Power Project Station

Draft Report

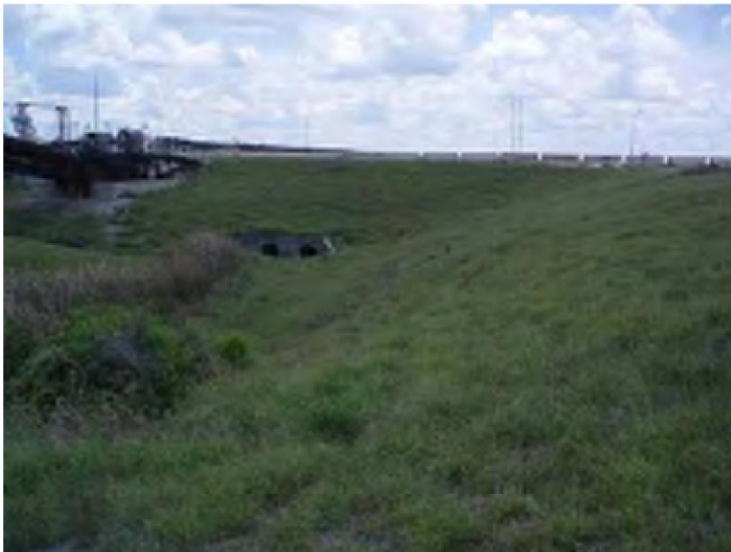
The exterior slope on the north appears to be in fair condition (Photos 2, 27, 34, 37, 38, 39, 40, 41, and 42). The grass on the north embankment ranged from 12 to 36 inches in height. Some minor brush and ~~huisache~~ ~~pricker~~ bushes were observed on the slope. Brush and trees were observed at the toe of the slope in the drainage ditch. Desiccation cracks up to a 1/2 inch wide and eight (8) inches deep were observed at various locations on the embankment face.

Photo No. 2: Reclaim Pond – North embankment exterior slope, looking east.

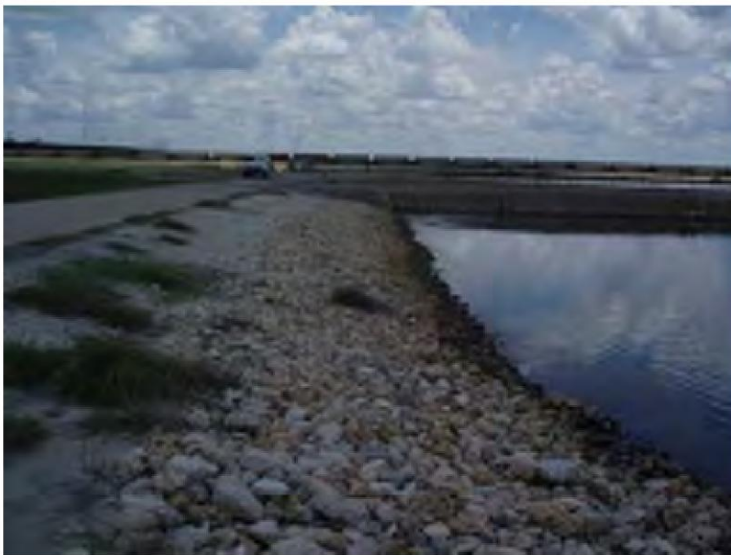
Photo No. 4: Reclaim Pond – North embankment interior slope, looking east

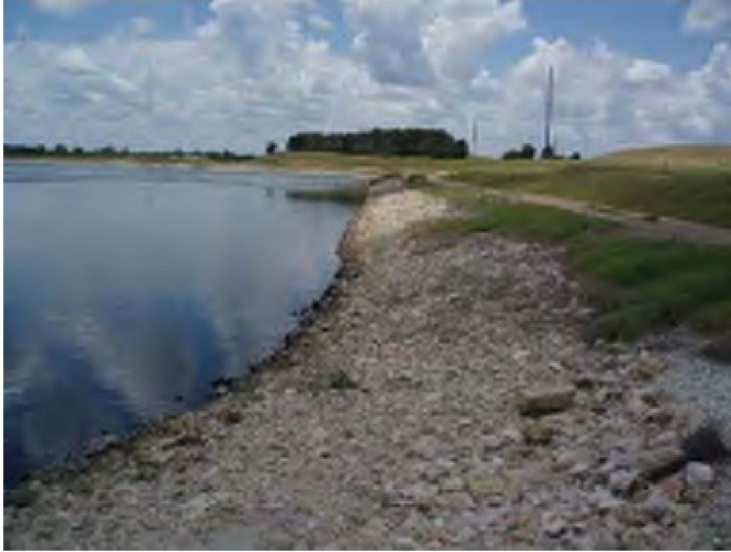
Photo No. 5: Reclaim Pond – West embankment interior slope, looking south.

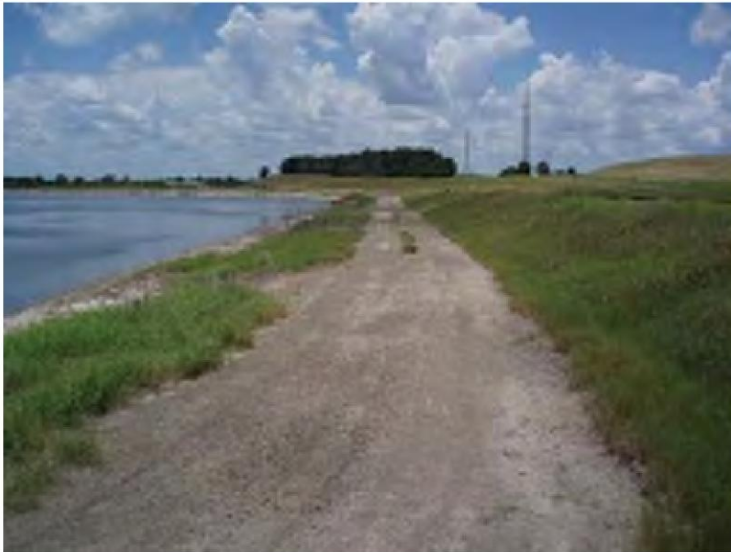
Photo No. 6: Reclaim Pond – West embankment crest, looking south.

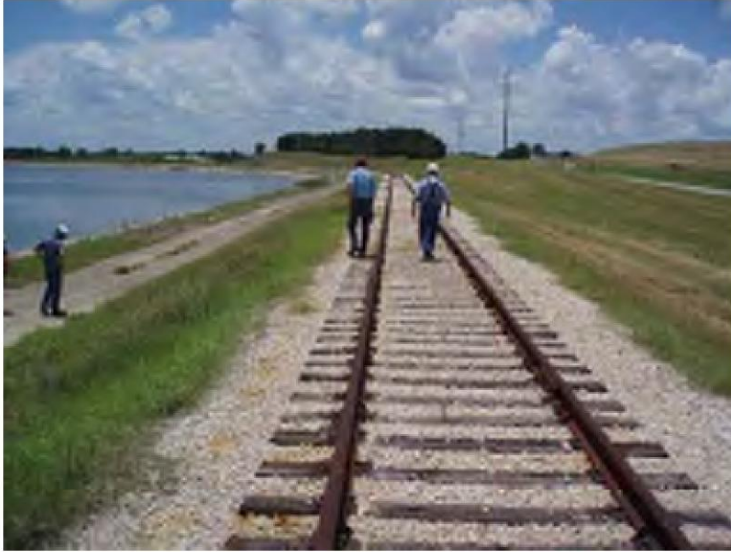
Photo No. 7: Reclaim Pond – Overview of west embankment from railroad spur, looking south.

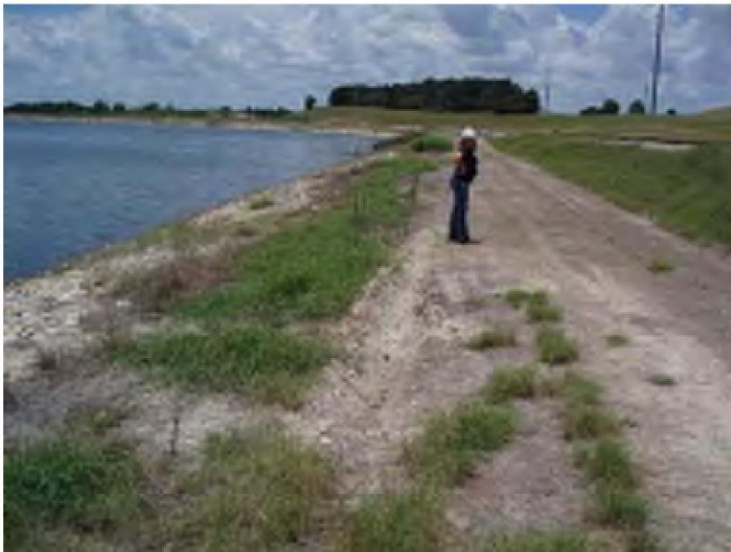
Photo No. 8: Reclaim Pond – West embankment, looking south at typical bare spots and tractor ruts on crest and interior slope.

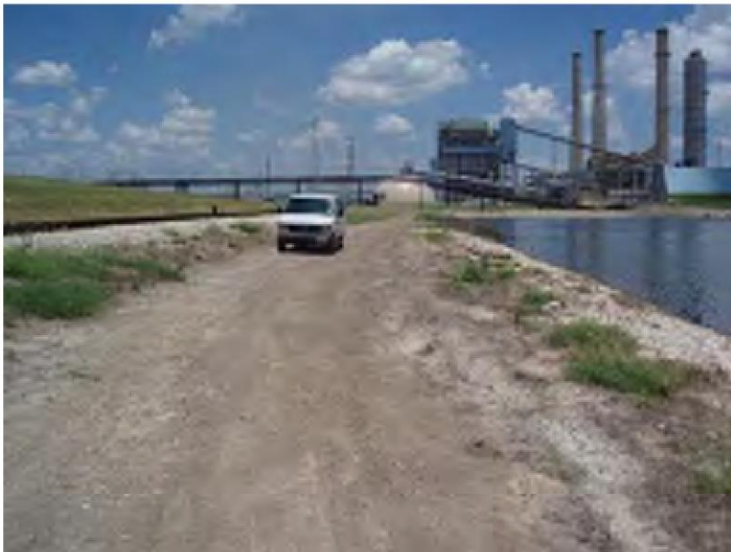
Photo No. 10: Reclaim Pond – West embankment crest, looking north at typical surface erosion and rutting.

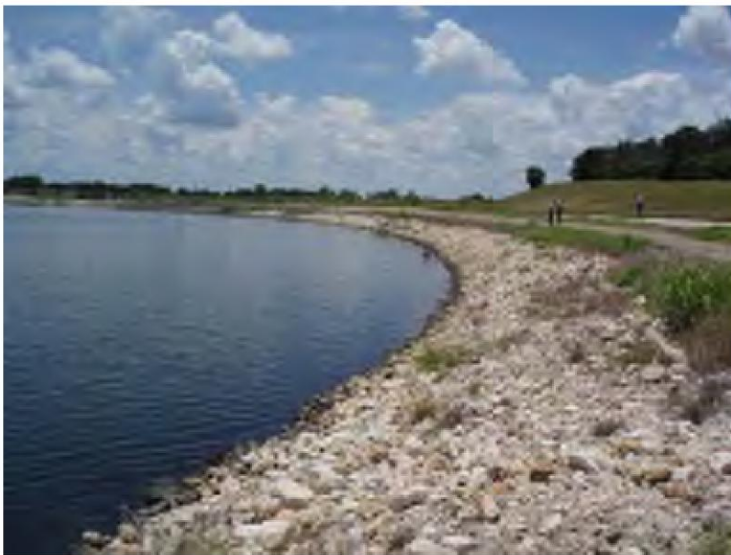
Photo No. 12: Reclaim Pond – South embankment interior slope, looking south.

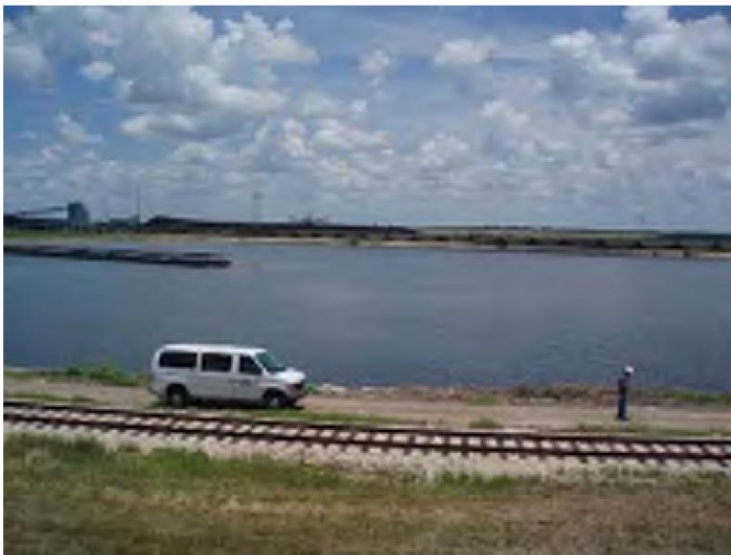
Photo No. 14: Reclaim Pond – Overview of impoundment, looking northeast.

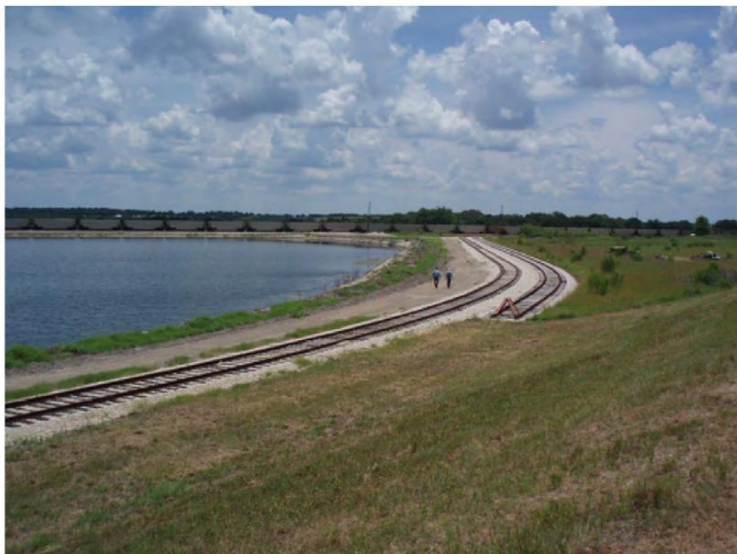
Photo No. 15: Reclaim Pond – Overview of south embankment, looking southeast.

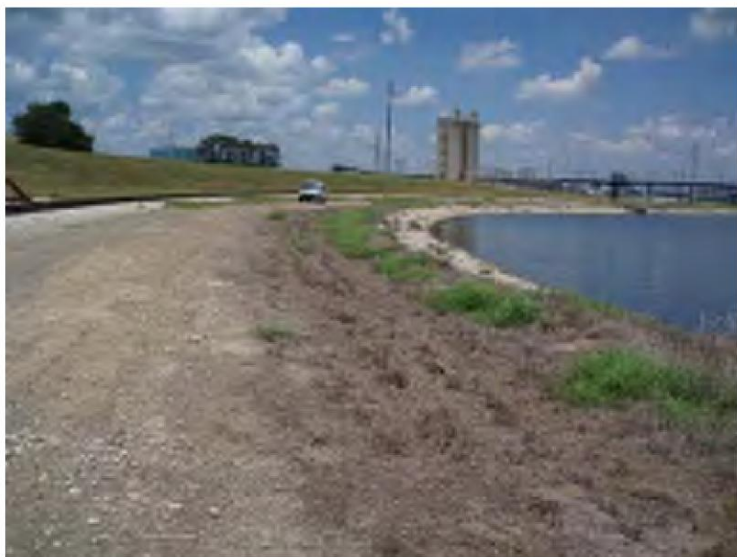
Photo No. 16: Reclaim Pond – South embankment, looking northwest at a low area on the crest

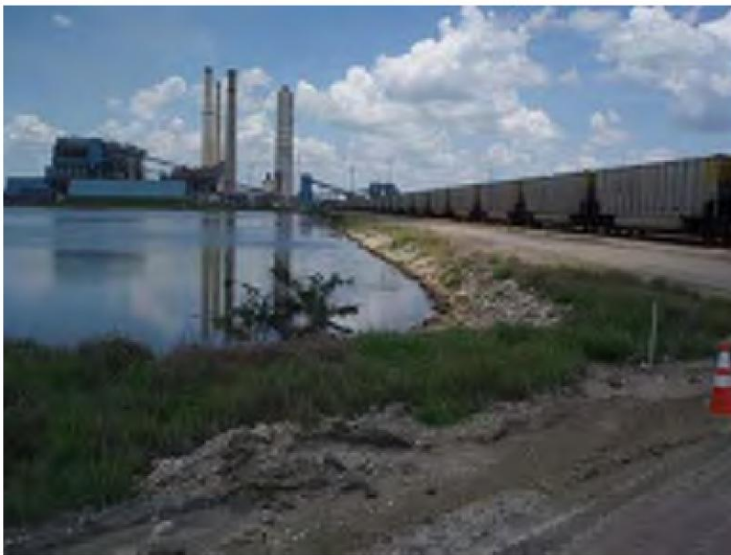
Photo No. 18: Reclaim Pond – East embankment interior slope, looking north. Small woody growth and minor surface erosion noted.

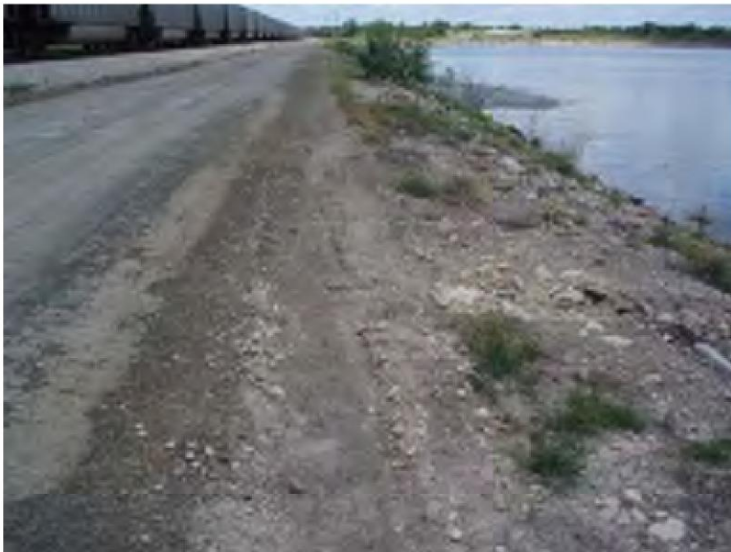
Photo No. 20: Reclaim Pond – East embankment interior slope, looking south at rutting and

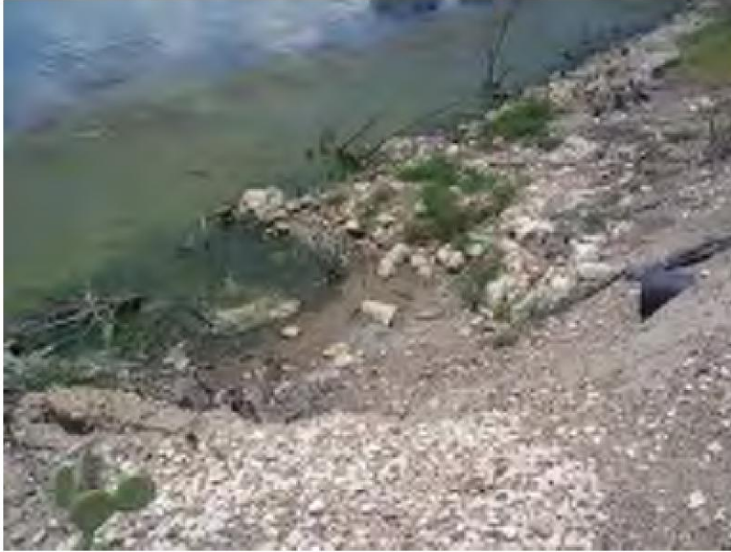
On the east embankment, there was one 2.5-foot-wide erosion rill (Photo 22). There was also an area where an abandoned 12-inch-diameter HDPE pipe from the CADP discharged into the Reclaim Pond. This area of the interior slope was eroded and some of the riprap was missing.

Photo No. 21: Reclaim Pond – East embankment interior slope, looking at abandoned 12-inch-diameter HDPE discharge pipe from the CADP. Note the embankment has been eroded at the discharge pipe.

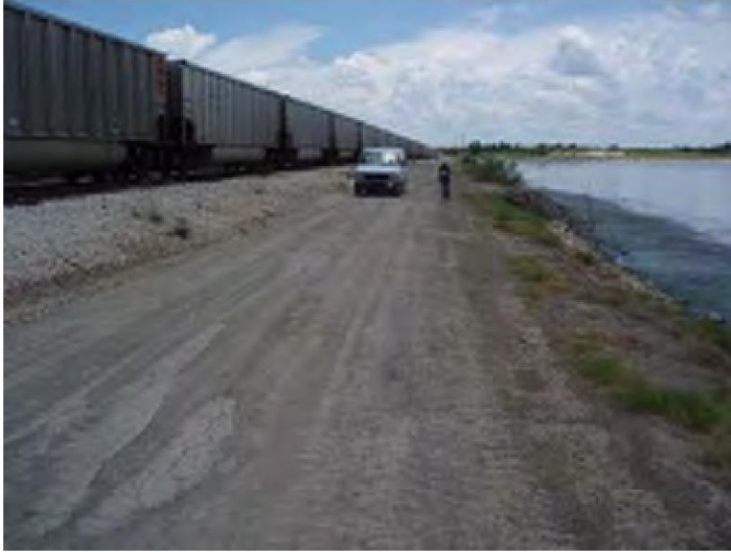
Photo No. 23: Reclaim Pond – East embankment crest, looking south.

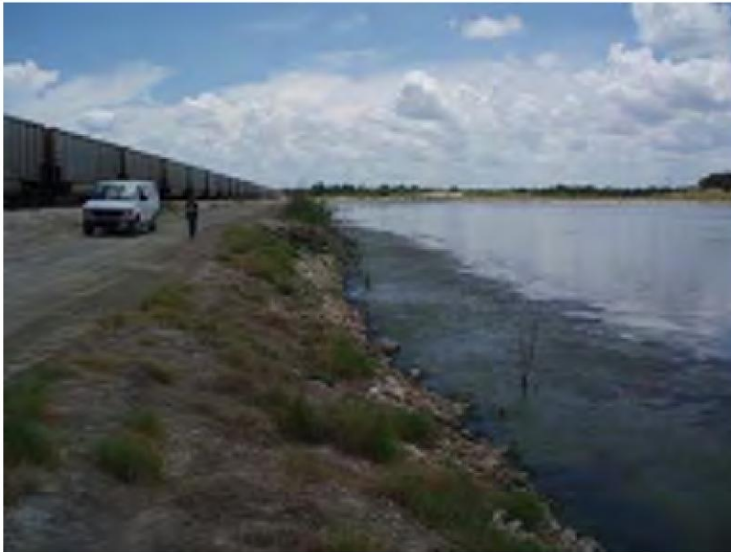
Photo No. 24: Reclaim Pond – East embankment interior slope, looking south. Note occasional mesquite trees growing on interior slope.

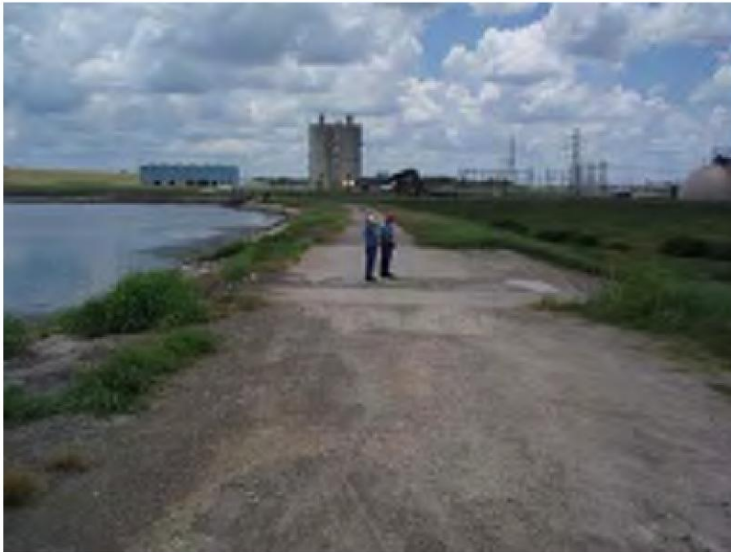
Photo No. 26: Reclaim Pond – North embankment crest, looking west.

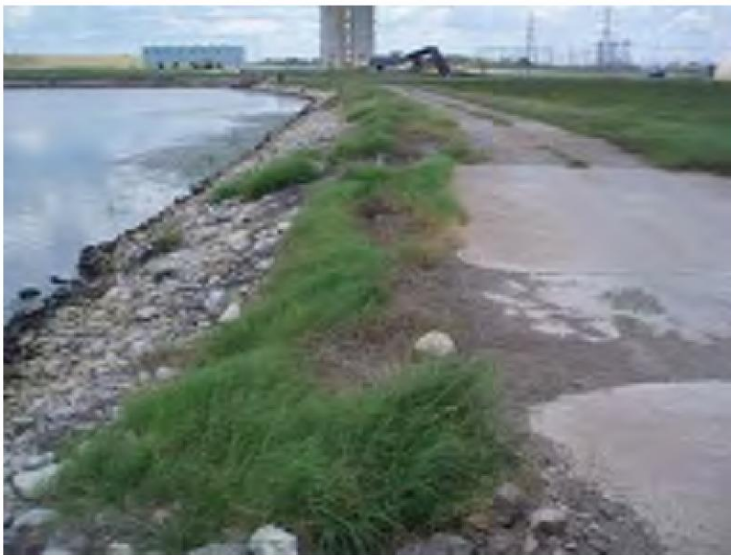
Photo No. 28: Reclaim Pond – North embankment, looking at emergency spillway channel entrance.

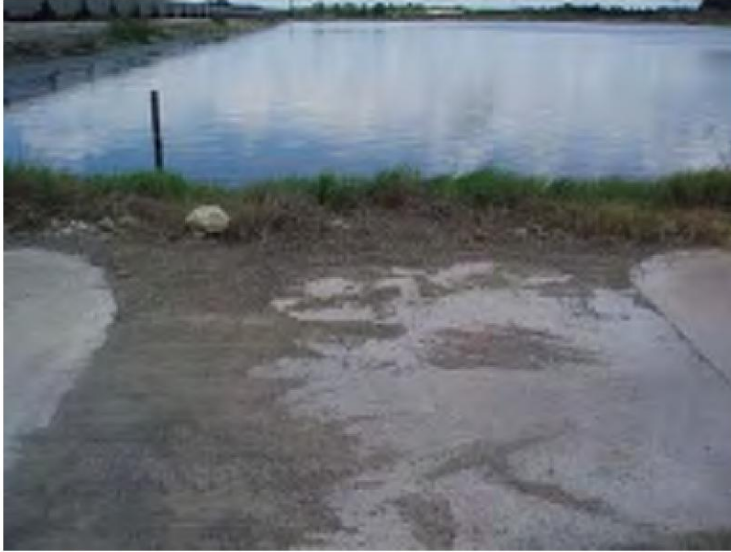
Photo No. 29: Reclaim Pond – North embankment, looking south at spillway channel entrance.

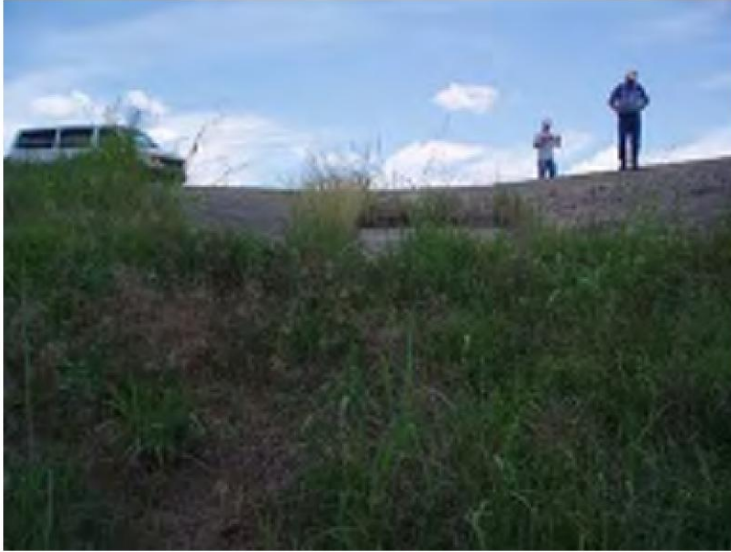
The emergency spillway appeared to be in fair condition (Photos 28, 29, 30, 31, and 41). The concrete lining was in good condition. The spillway discharge channel had some minor grass growing in the channel. The entrance to the spillway channel had excessive vegetation and there was missing riprap. There was also excessive vegetation in the outlet channel.

Photo No. 31: Reclaim Pond – North embankment exterior slope, looking south at spillway discharge channel.

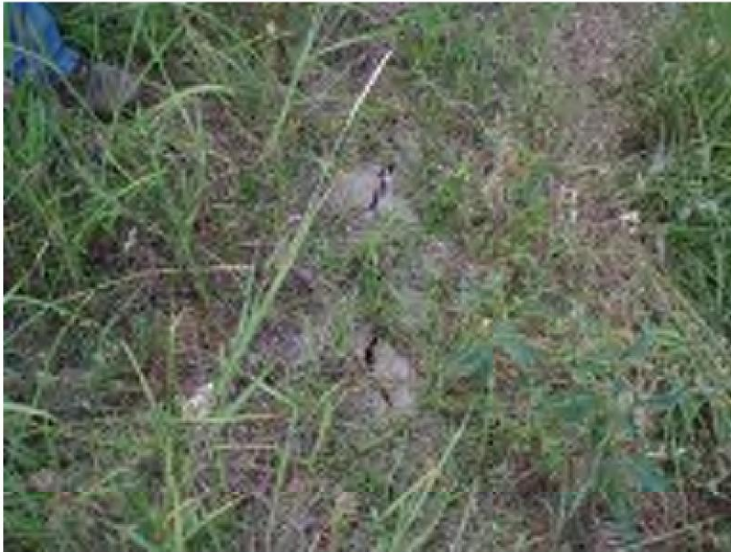
Photo No. 32: Reclaim Pond – North embankment exterior slope, looking at typical desiccation cracks.

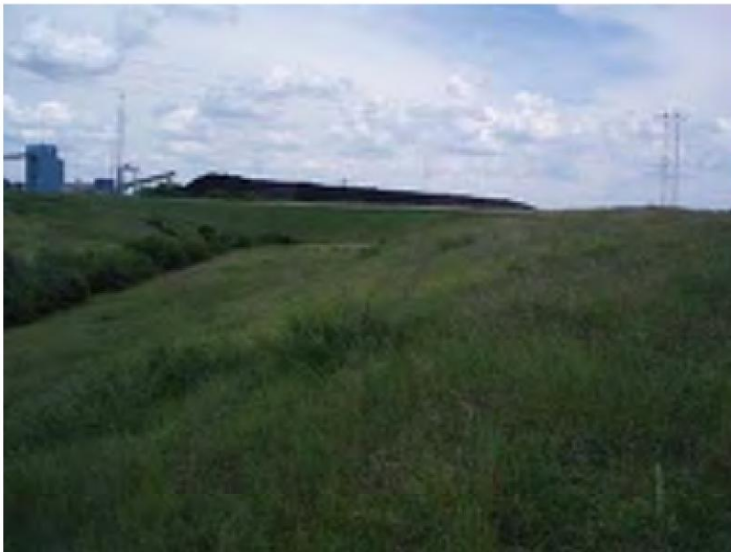
Photo No. 34: Reclaim Pond – North embankment exterior slope, looking east.

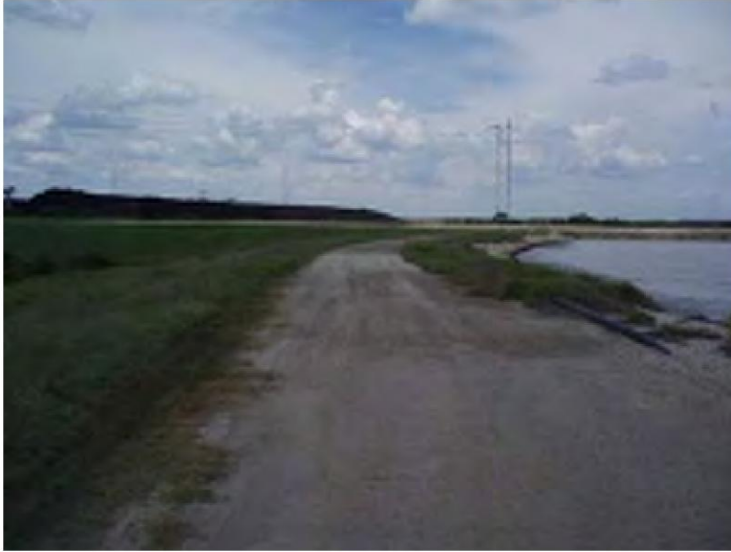
Photo No. 35: Reclaim Pond – North embankment crest, looking east.

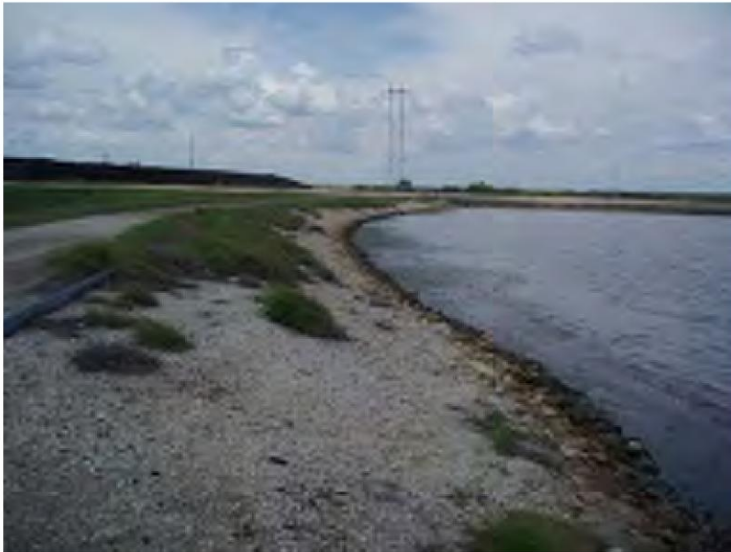
Photo No. 36: Reclaim Pond – North embankment interior Slope, looking east. Note 6-inch-

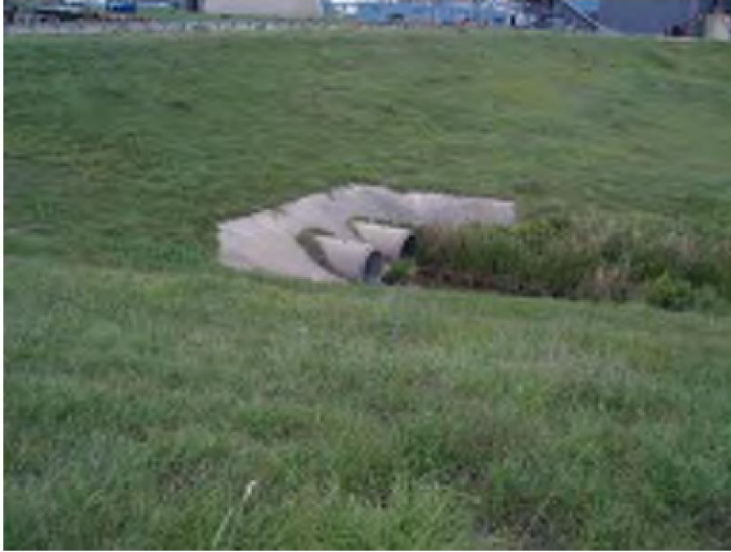
Photo No. 37: Reclaim Pond – North embankment exterior slope, looking north at two 8-foot-

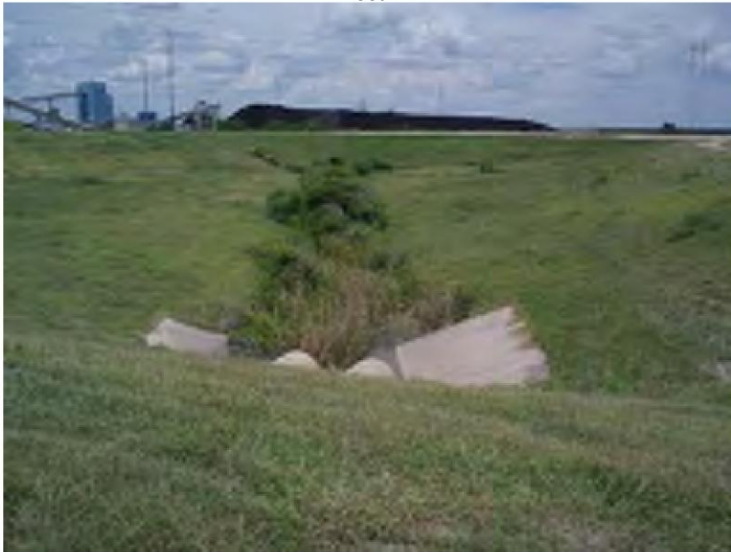
Photo No. 38: Reclaim Pond – Overview of north embankment exterior slope and downstream area, looking east. Note small trees and brush at the bottom of the slope growing in the drainage ditch.

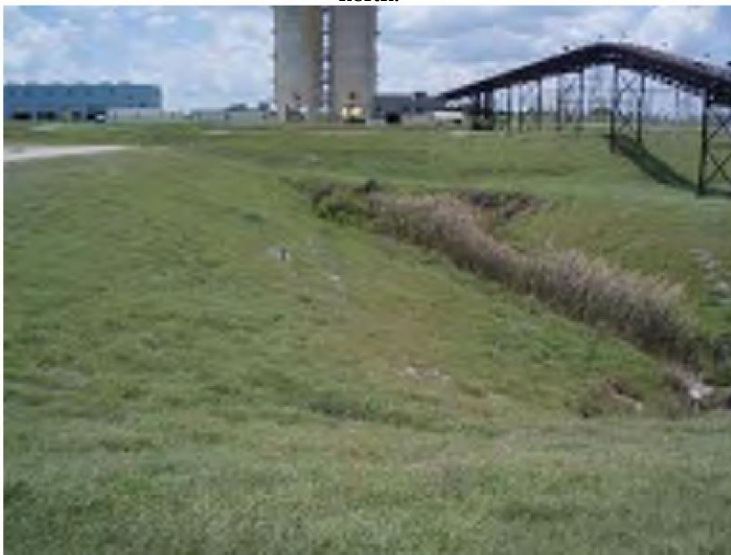
Photo No. 40: Reclaim Pond – Overview of north embankment exterior slope and downstream area, looking west

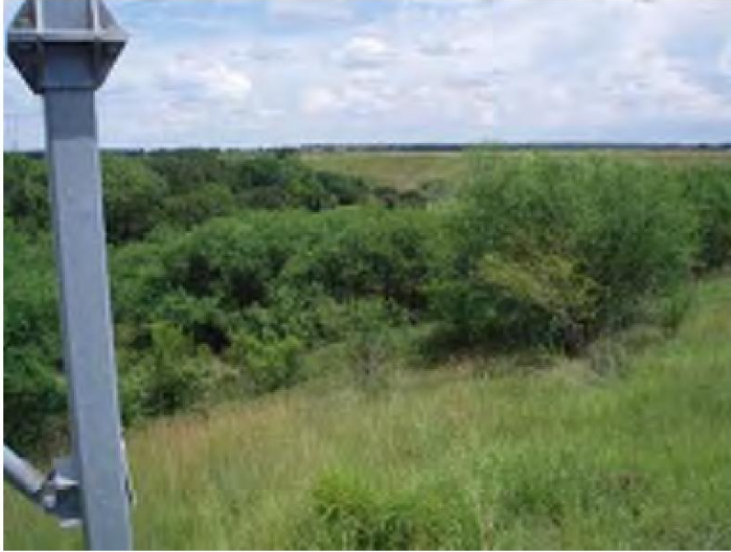
Photo No. 43: Reclaim Pond – East embankment downstream area, looking southeast.

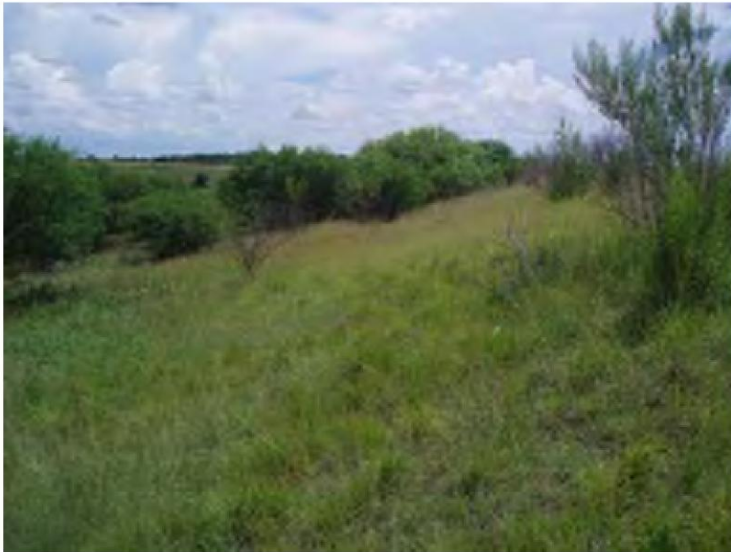
The exterior slope face on the east ~~is~~ embankment is generally poor (Photos 43, 44, 46, 47, 48, 50, and 51). The grass on the east embankment ranged from 12 to 36 inches in height. Brush and mesquite trees as large as 30 inches in diameter were observed on the embankment. Desiccation cracks up to a 1/2 inch wide and 8 inches deep were observed at various locations on the embankment. A flyash surfaced access road was observed on the exterior slope of the embankment (Photos 48 and 50).

Photo No. 44: Reclaim Pond – East embankment exterior slope, looking south.

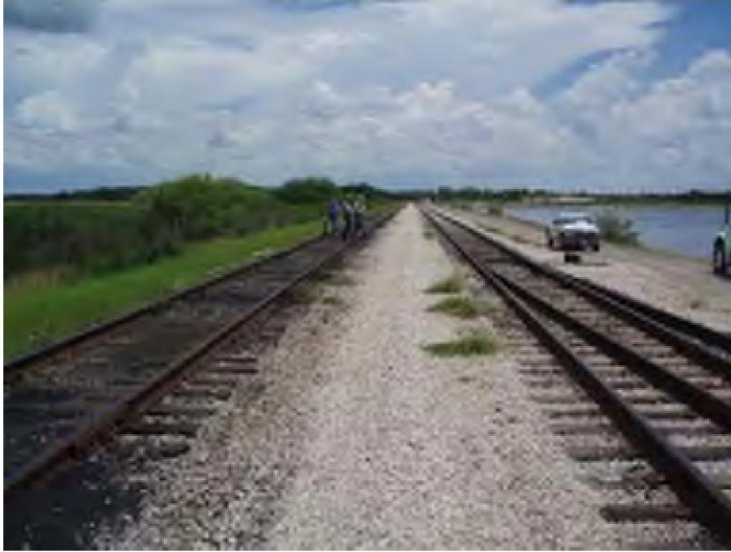
Photo No. 45: Reclaim Pond - East embankment crest, looking south. Note crest has two railroad spurs and an access road.

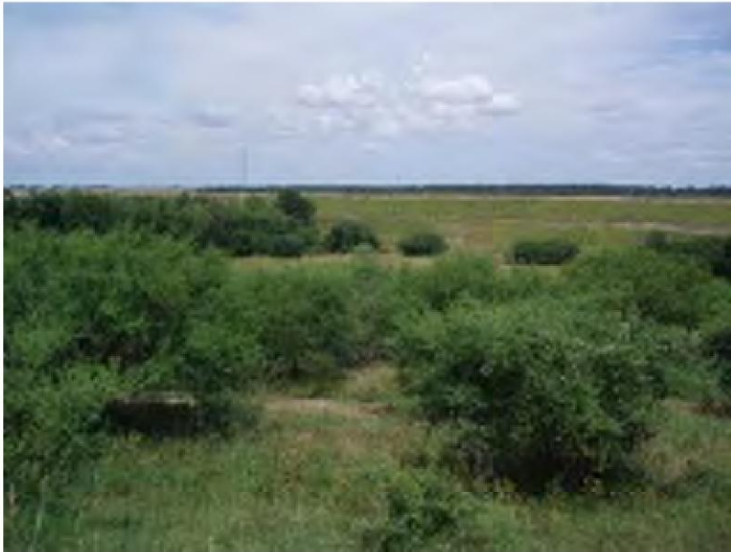
Photo No. 46: Reclaim Pond - East embankment exterior slope, looking east at downstream area. Note railroad embankment in background.

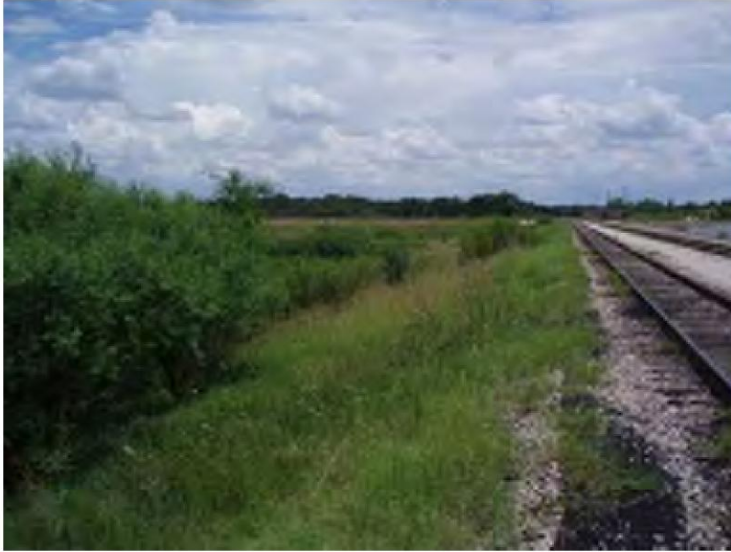
Photo No. 47: Reclaim Pond - East embankment exterior slope, looking south.

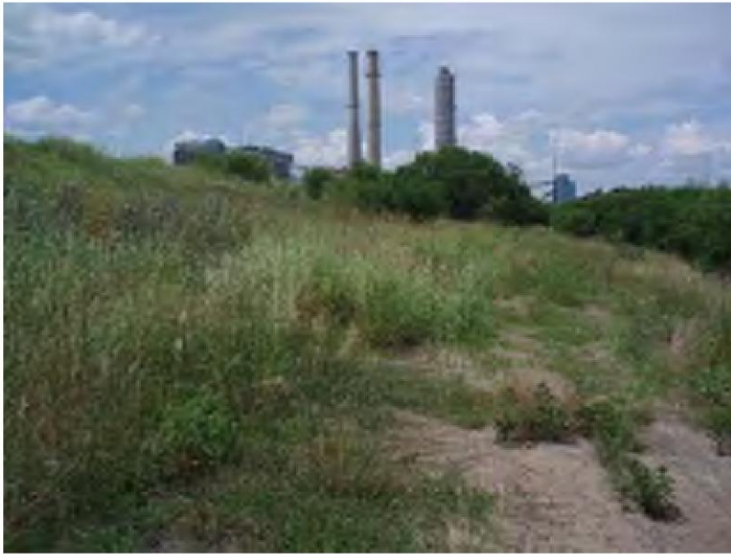
Photo No. 48: Reclaim Pond - East embankment exterior slope, looking north.

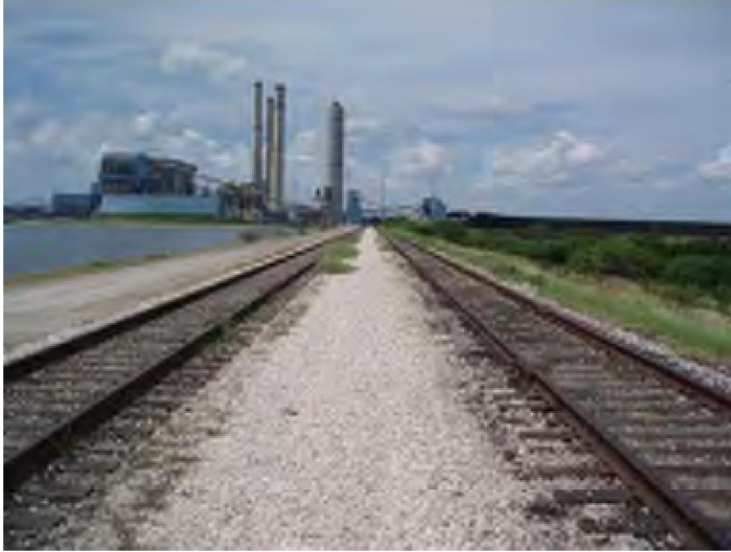
Photo No. 49: Reclaim Pond – East embankment crest, looking north.

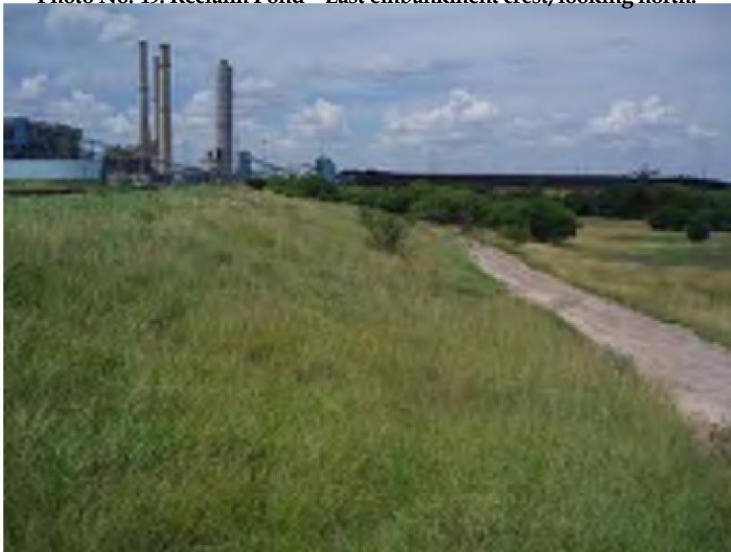
Photo No. 50: Reclaim Pond – East embankment exterior slope, looking north. Note access road to monitoring wells.

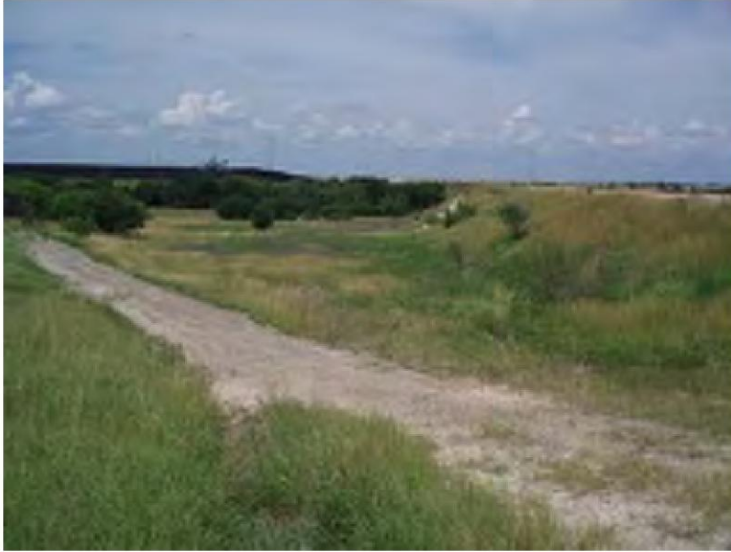
Photo No. 51: Reclaim Pond – Overview of east embankment downstream area. Note railroad embankment to the right side of photo.

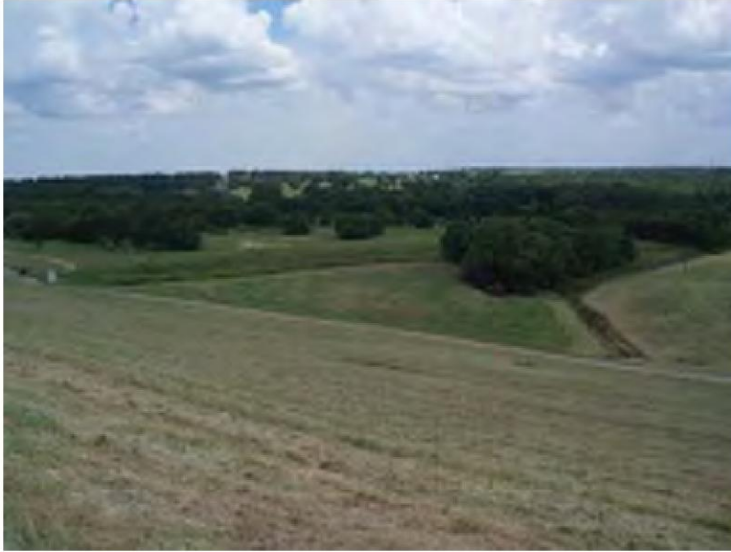
Photo No. 55: CADP – Overview of east embankment downstream area, looking southeast.

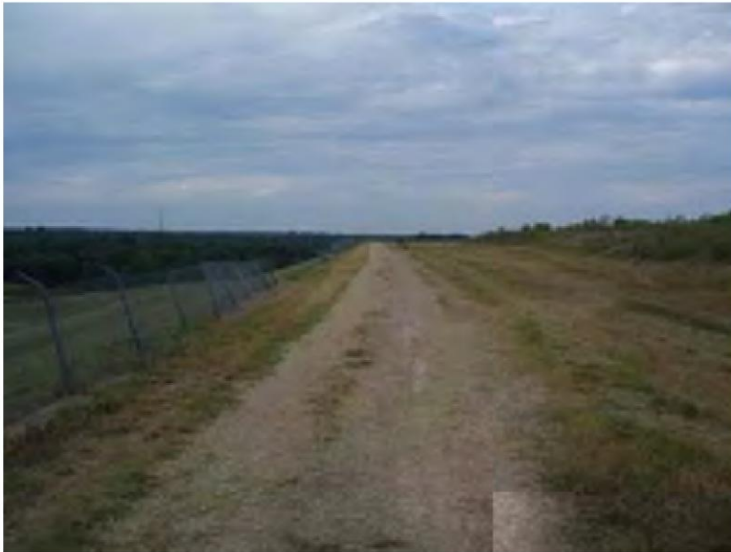
Photo No. 56: CADP – East embankment crest, looking south. Note the fence has been pushed over from raising the crest 2 feet.

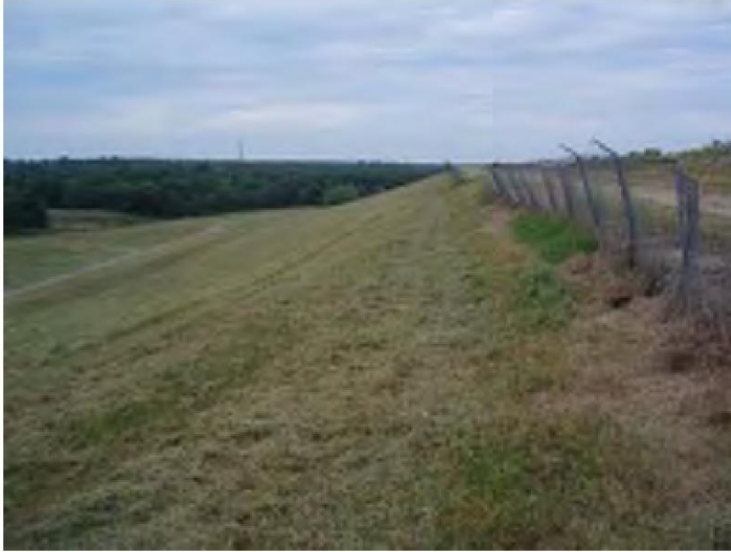
Photo No. 57: CADP - East embankment exterior slope, looking south.

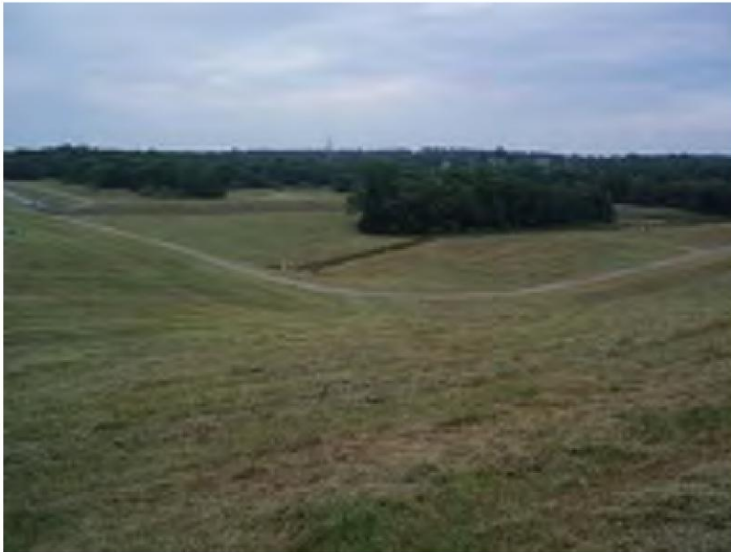
Photo No. 58: CADP - East embankment exterior slope, looking southeast at groin with

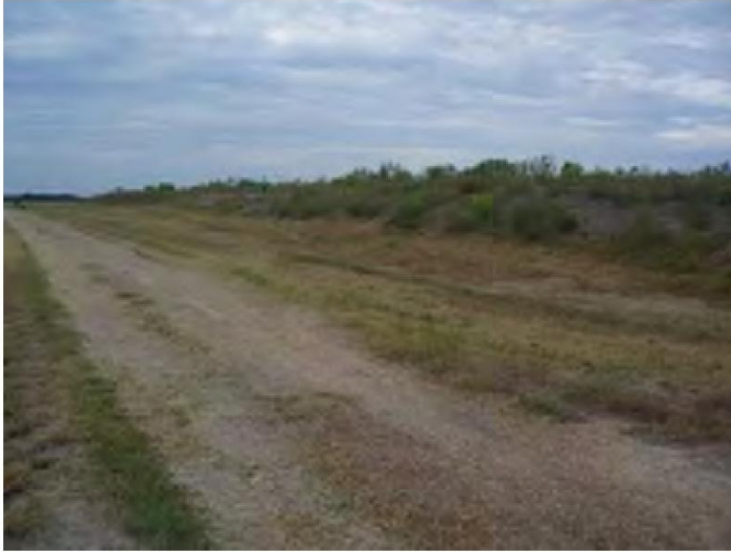
Photo No. 59: CADP - East embankment interior slope, looking southwest.

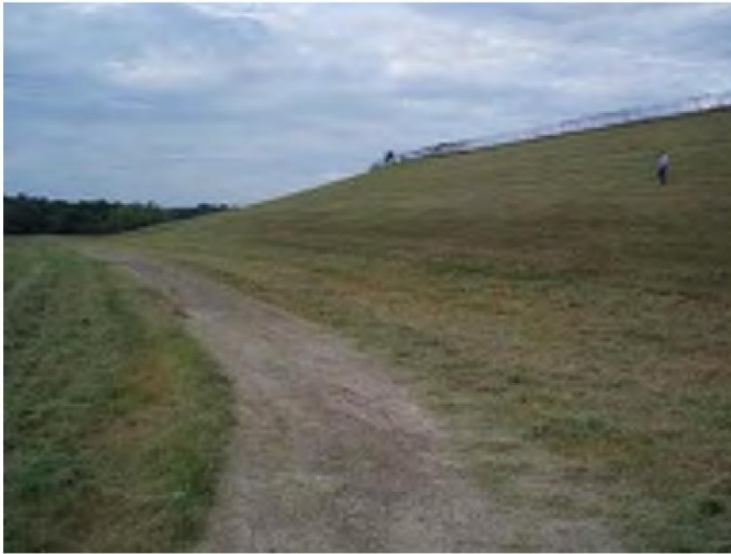
Photo No. 60: CADP - East embankment exterior slope looking southwest.

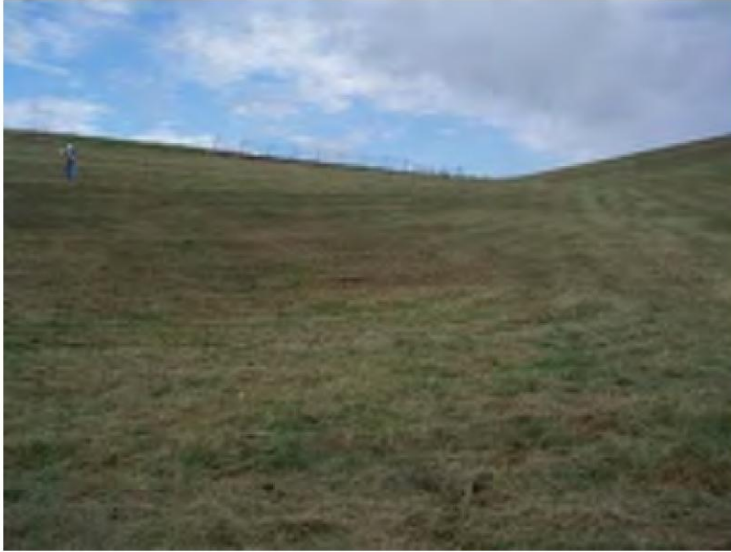
Photo No. 61: CADP – East embankment exterior slope, looking northwest at groin with Cedar Creek Dam.

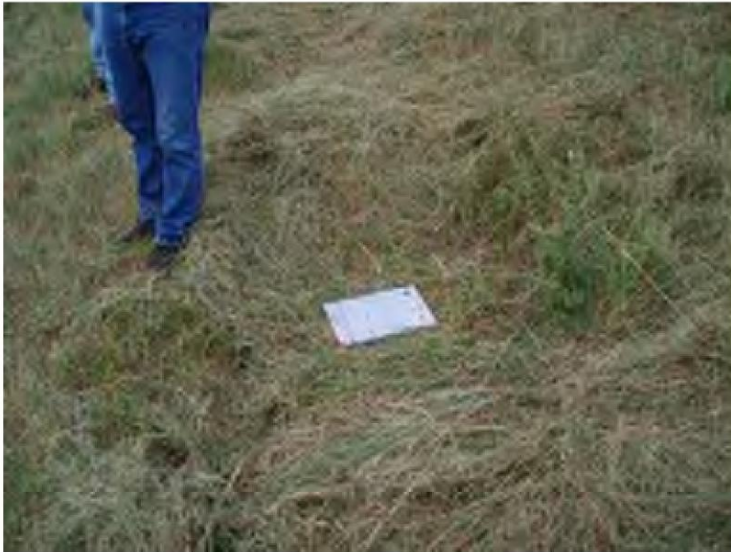
CDM observed 16 rodent holes, reportedly made by armadillo's, on the east embankment exterior slope. The holes ranged in size from 4 to 8 inches in diameter (Photos 63 and 65). There were also multiple surface depressions that were likely rodent holes that collapsed, possibly as a result of mowing operations (Photos 62, 79, 80, and 84).

Photo No. 62: CADP – East embankment exterior slope, looking at 3'Wx3'Lx1'D depression. Possible collapsed rodent burrow.

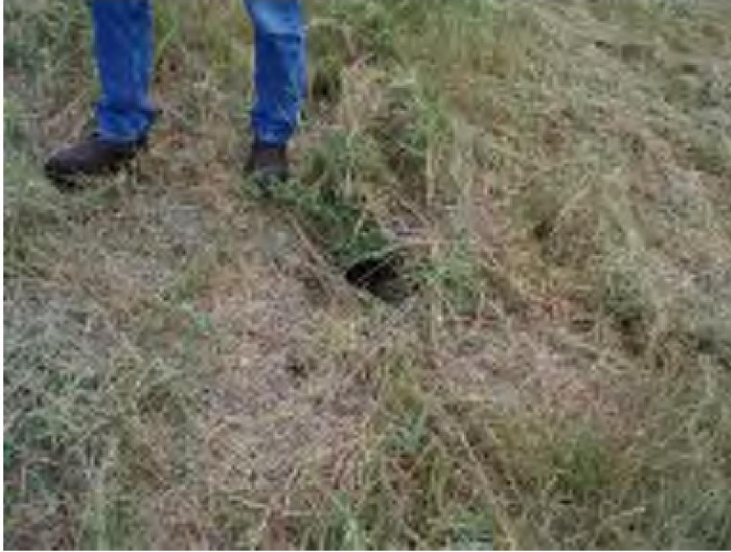
Photo No. 63: CADP - East embankment exterior slope, looking at a 6-inch-diameter rodent

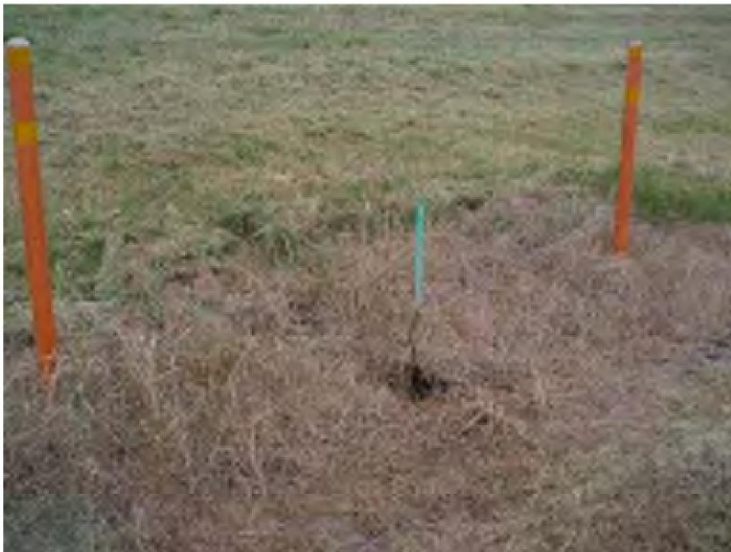
Seepage was not observed in the sump pit during the site visit. The ground around the other discharge pipe (Photo No. 64) was damp, although no significant seepage was observed.

Photo No. 64: CADP - East embankment exterior slope, looking at toe drain

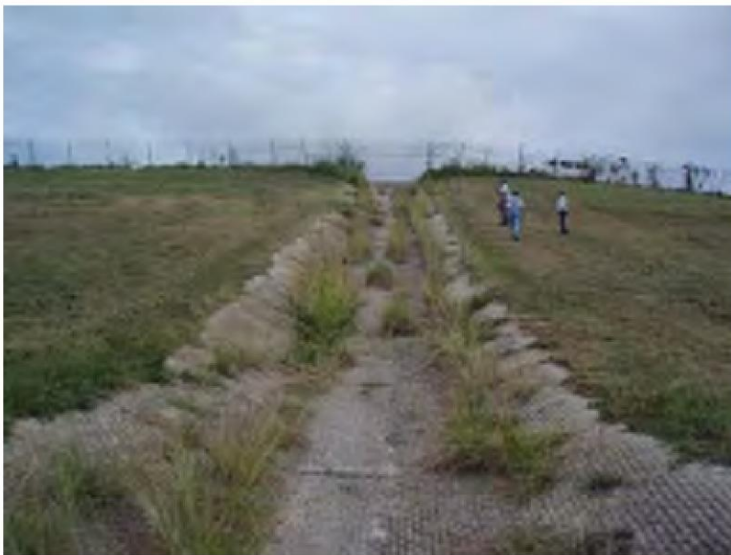
Photo No. 68: CADP - East embankment exterior slope, looking west at stormwater discharge channel from capped portion of the impoundment.

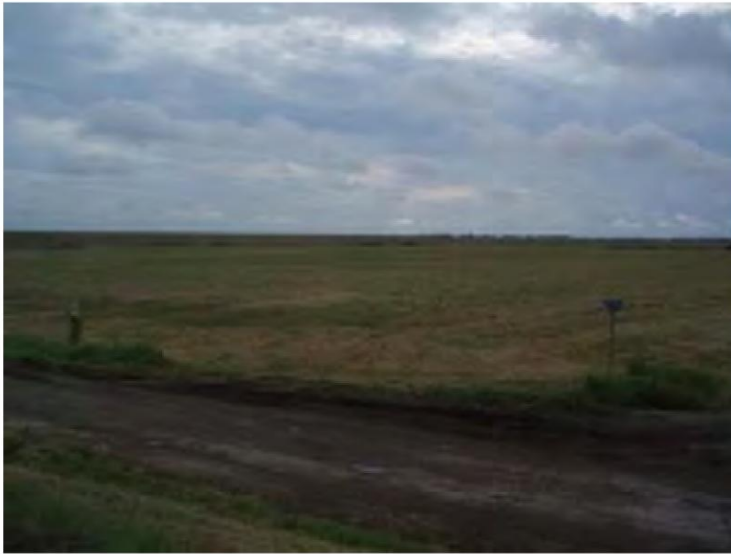
Photo No. 88: CADP - Overview of capped area, looking northeast from southwest corner of

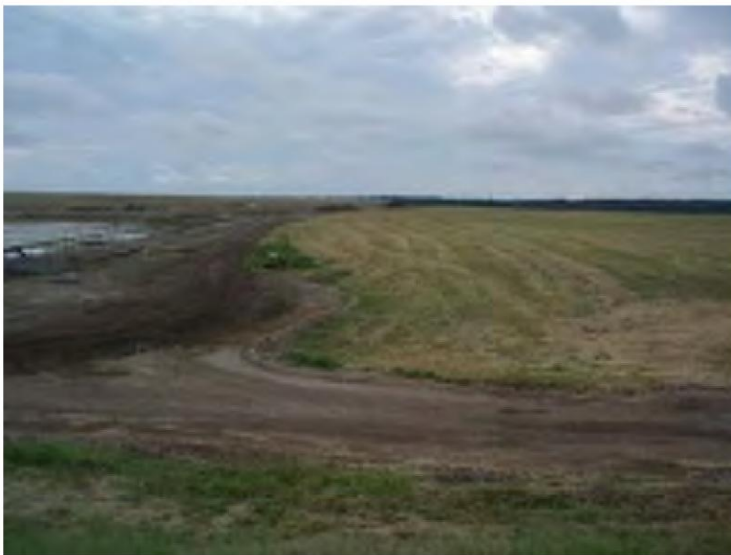
Photo No. 90: CADP – overview of transition between the active and the capped portion of

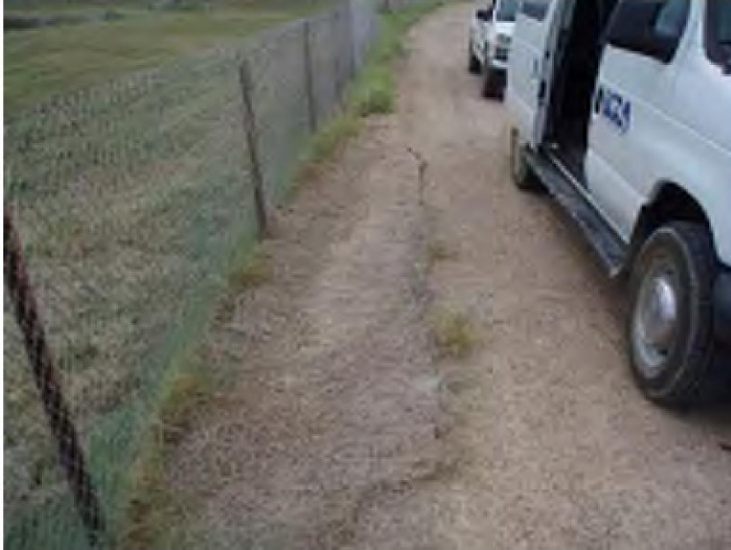
Photo No. 99: CADP – North embankment crest, looking at tension crack in road base

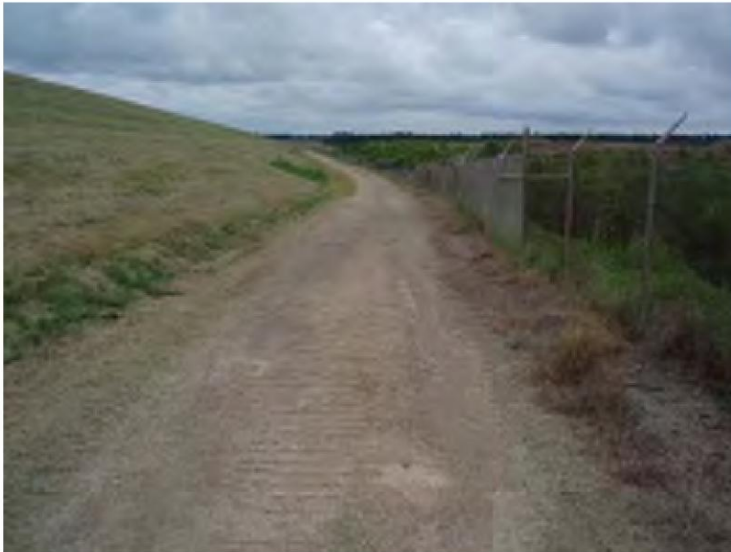
Photo No. 100: CADP – North embankment crest, looking east. Note trees growing inside the fence limits. Trees are in the area of the toe of the Cedar Creek Dam.

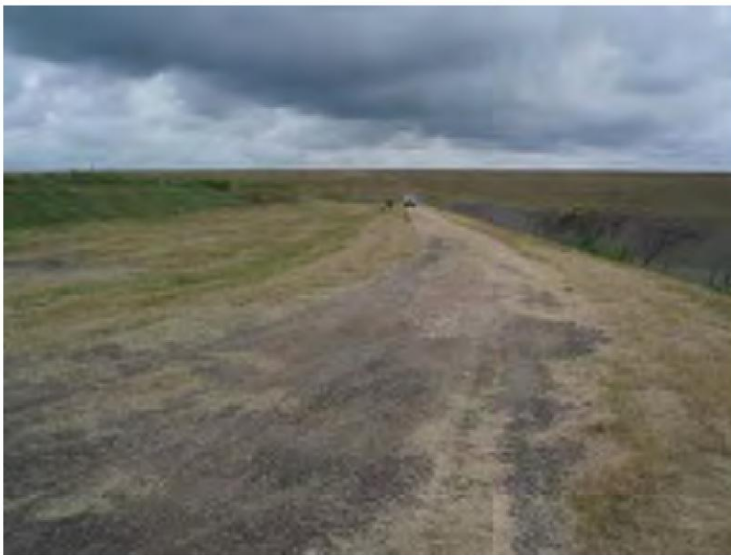
Photo No. 102: CADP - East embankment crest, looking north.
